Report No. CG-D-08-16

Immersion Suit Flotation Testing

REACT Report

August 2016

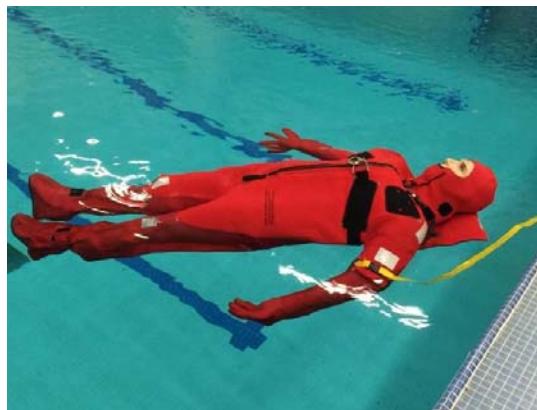
Figure 5. Weighted mannequin/immersion suit flotation trial.

The initial flotation test (see Figure 5) indicated conditions that differ from a “real world” situation. First, in “normal” immersion-suit wear, the wearer’s posture is often different than shown in Figure 5. In a resting position, a wearer’s body would exhibit a bend at the waist-pelvis region, where the rump would sink lower, with the feet and legs tending upward. This, in-turn, would cause the wearer’s torso and head to rest at a greater angle with respect to the surface of the water. Second, for our mannequin, both weighted arms appeared to swivel or detach from their initial positions alongside the mannequin torso. The immersion suit kept the arms captive, but did not provide the rigidity as initially desired. For comparison, Figure 6 gives an example of an actual wearer’s position in the water. For our purposes, we accepted the difference in flotation aspect as an experiment constraint.

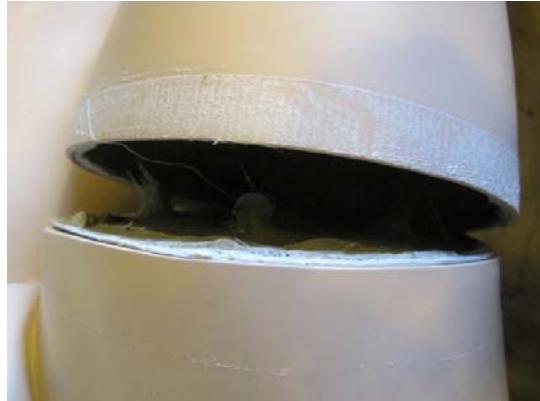
The first step was to re-ballast the mannequins as before, using the divers' weights, belts and buckles, and over-taping (Figure 8). After initial ballasting, a problem occurred. During a logistics run for PVC tubing, the fiberglass thigh stub-end for a removable leg mount detached at the seam due to shear force created by the weights. Though the display mannequin was not designed for anything but a "stand-up" mode, the failure indicated the joint relied only on a narrow, resin and filler seam (Figure 9). We tried, unsuccessfully, to find a fiberglass repair-kit at one of the CG units at the Mobile facility, so decided to try to "bandage" the seam with duct tape, applied parallel to the axis of the leg, then wrapped circumferentially (Figure 10).

Figure 9. Mannequin leg-joint separation.

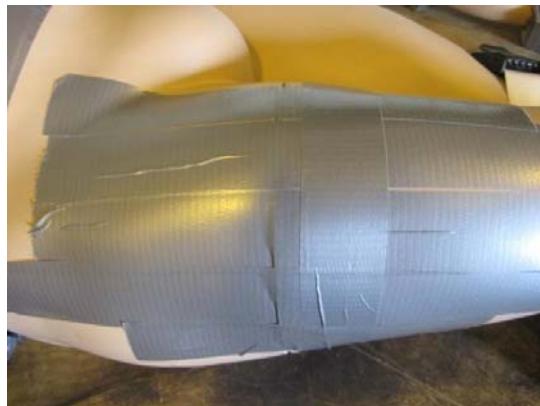
Figure 10. Mannequin duct-tape “bandage.”

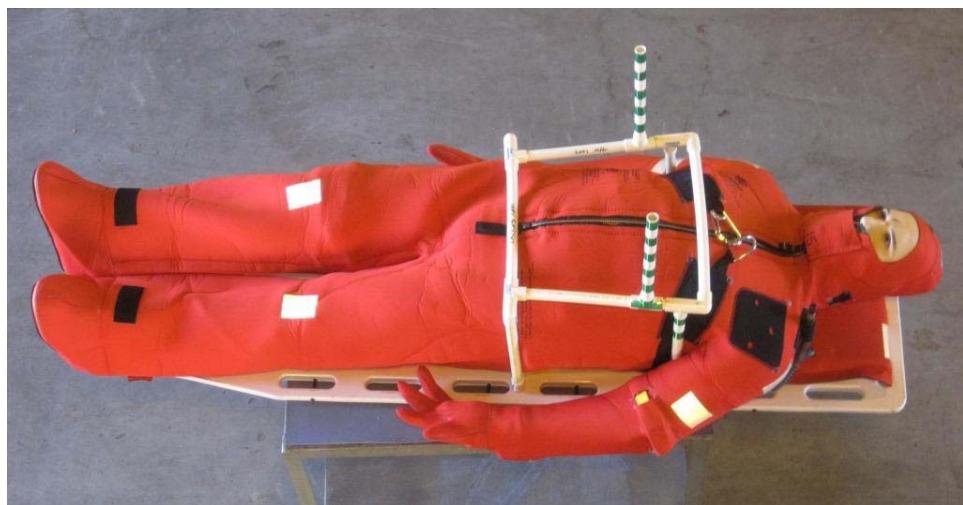
Figure 11. Mannequin in suit with measuring posts.

After ballasting and suiting the mannequins, the team constructed a frame of $\frac{3}{4}$ -in CPVC tube and fittings around each mannequin to support vertical “measurement posts.” One-inch red and green retro-reflective tape strips, spaced one inch apart, provided a means to tell whether the mannequins lost buoyancy during the deployment (Figure 11).

The team then weighed each fully-outfitted mannequin on an electronic platform scale, being extremely careful not to puncture the suits on the sharp edges of the scale, by using an immobilization backboard, as seen extending past the mannequin in Figure 11, above. Pre-deployment weight was 210 pounds for each mannequin, including suit.

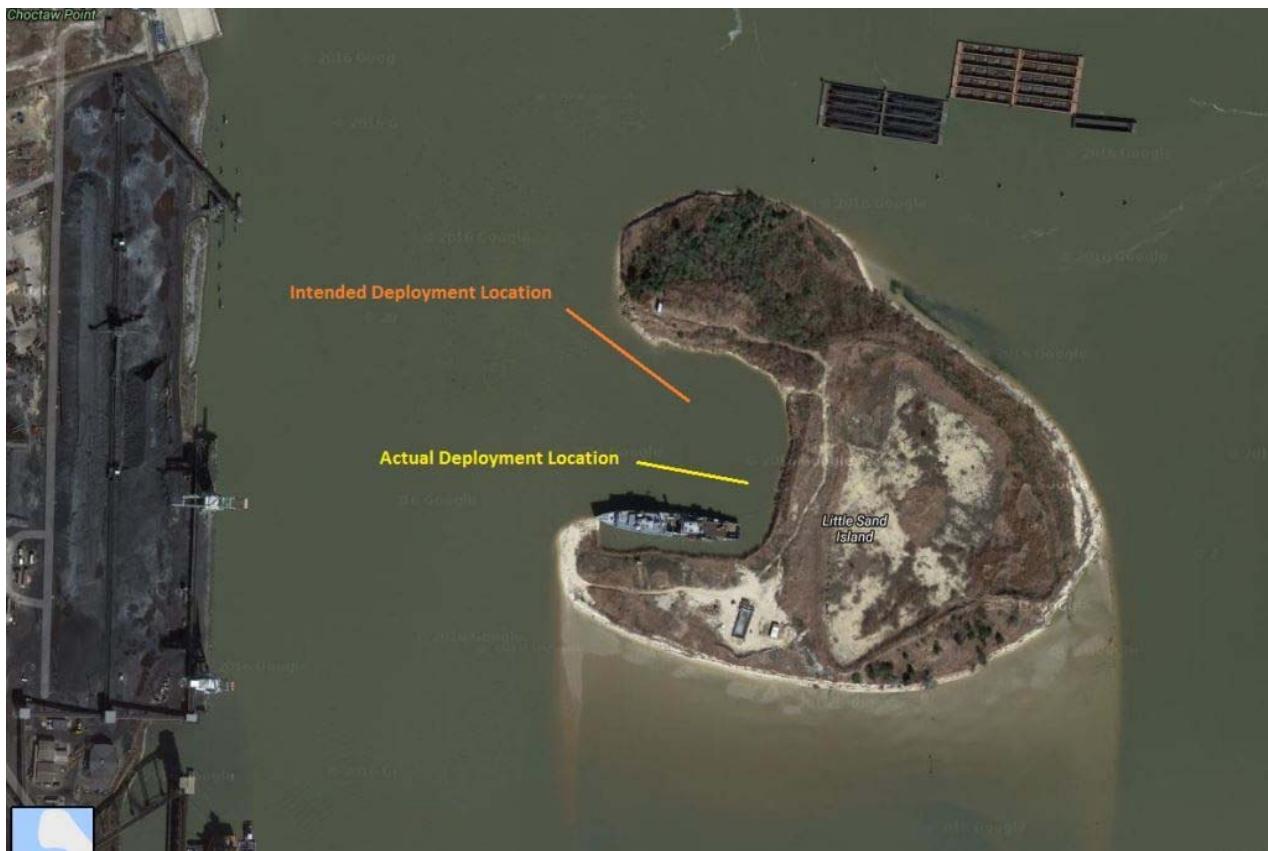
Figure 12. Actual versus intended deployment site, Little Sand Island basin.

Using a telehandler and pallets, JMTF staff and test team loaded all gear onboard the 35-foot NRL Landing Craft Mechanized (LCM-3), and proceeded to the test site in the Little Sand Island basin. The NRL LCM operator recommended a site closer to the east side of the basin than indicated on the test plan due to recent dredge-pipe staging activity (Figure 12). Estimated water depth was 12 feet.

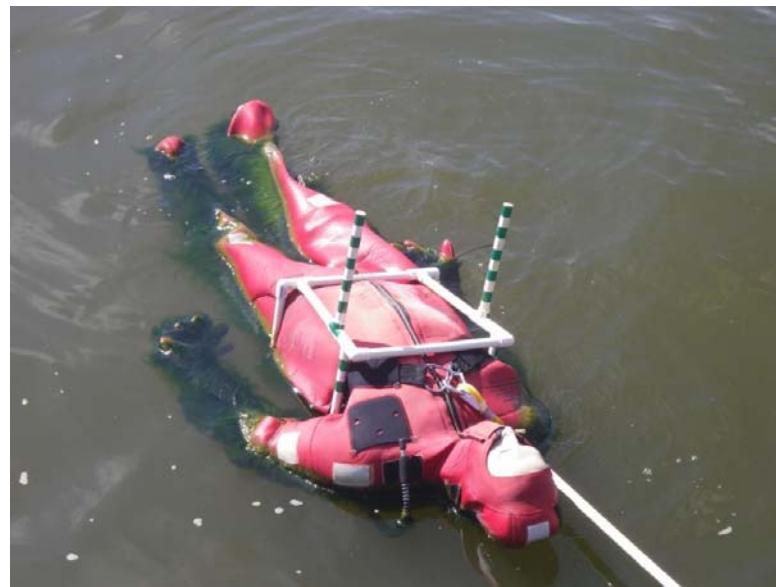
Figures 16 and 17 taken just before the time of recovery clearly indicate that both mannequins exhibit **significant** grassy marine growth about their “waterlines,” especially over the legs and arms.

Figure 16. Mannequin A – pre recovery 23 June 2016.

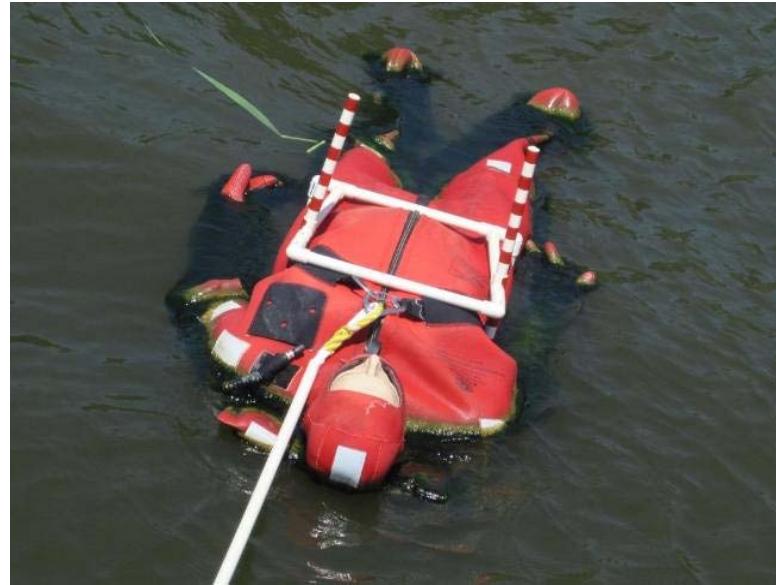
Figure 17. Mannequin B – pre recovery 23 June 2016.

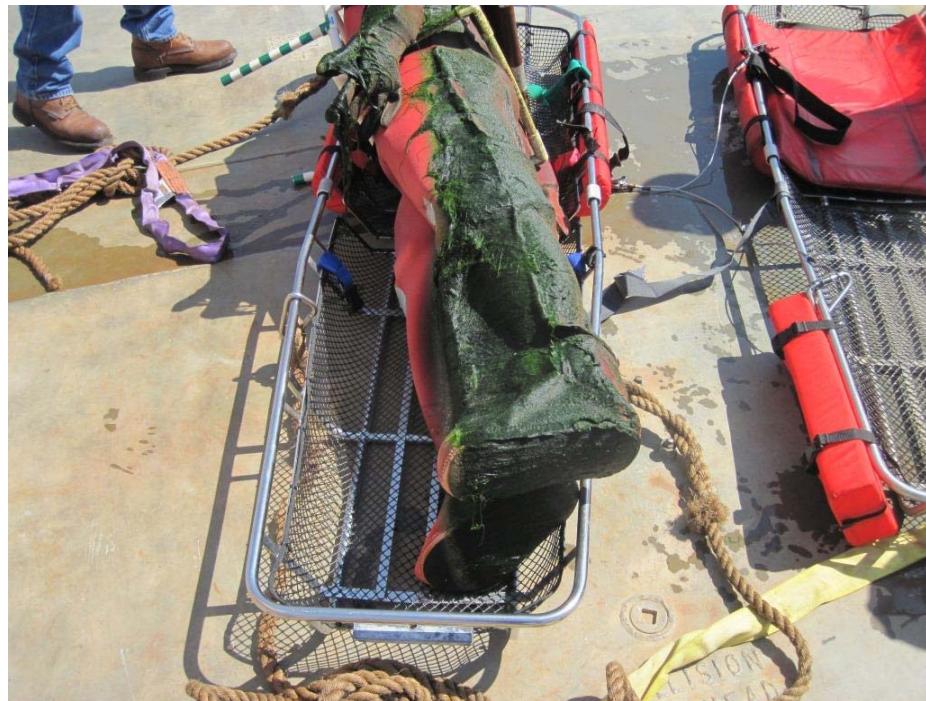
We must reemphasize the amount of marine growth that formed on the mannequins during the two-week deployment. Though clearly visible in the pre-recovery photographs above (Figures 16 and 17), Figure 21, taken immediately after recovery of Mannequin A, provides further documentation the extent of the marine growth.

Figure 21. Mannequin A, post-recovery, extensive marine growth.

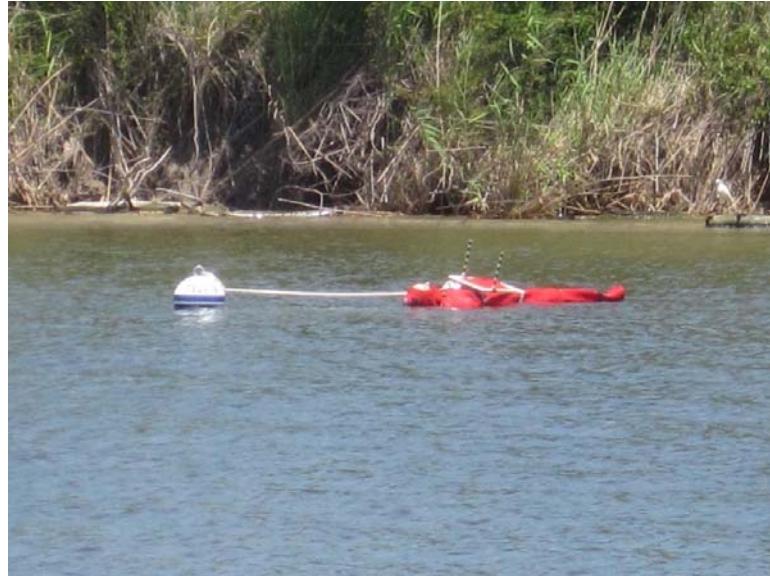
Figure 22. Mannequin A- deployment 0800 8 June 2016.

Initial readings on “measurement posts,” with one-inch tape bands, one-inch apart, indicated that both mannequins were floating higher than the lowest mark. At this stage, there was nothing to do about the measurement marks, however the accompanying photos for each reading allowed a good comparison of flotation height. Comparison of Figures 22 and 23 indicate a distinct “list” for Mannequin A.

The notes in the daily measurement record (Appendix D) frequently indicate an almost continuous list to the right for Mannequin A. Though not reflected in the flotation testing data sheet notes, photos starting on 15 June (Appendix E) document the appearance of marine growth at the approximate waterline for both mannequins. As pre-recovery photos (Figures 16 and 17, earlier) show, over the final seven days, the marine growth became quite significant.

Regarding Mannequin A's list, the test team believes that as they fastened the ballast weights, they may have skewed the weight to one side of the mannequin torso. From the photos or the observation records, we cannot determine if Mannequin B's "broken leg" affected its list or trim. What is apparent in all photos is the overall trim of the mannequins (torso higher than the legs) due to the nature of the rigid mannequins used.

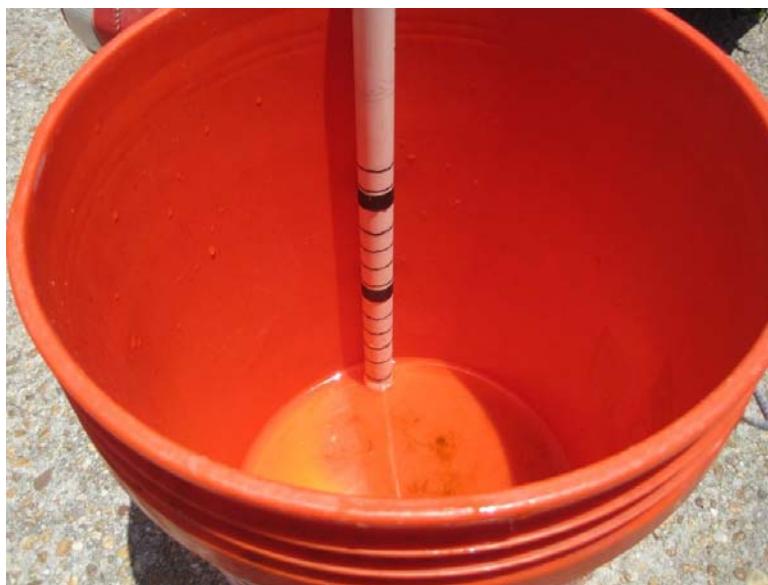
After the post-recovery weighing, the RDC team opened the immersion suit for Mannequin A, and noticed pooled water in area of lower back/buttocks, as mentioned earlier. As best possible, we collected this and any additional water from the legs and arms into a six-gallon bucket. Using a pre-marked tube section (smallest gradation of one liter), we measured approximately three-quarters liter (approximately 1.7 pounds) from Mannequin A. We followed the same procedures, and recovered less than one-third liter (approximately 0.7 pounds) from Mannequin B. Figures 24 and 25 show the measure results.

Figure 24. Mannequin A- post-recovery drained water.

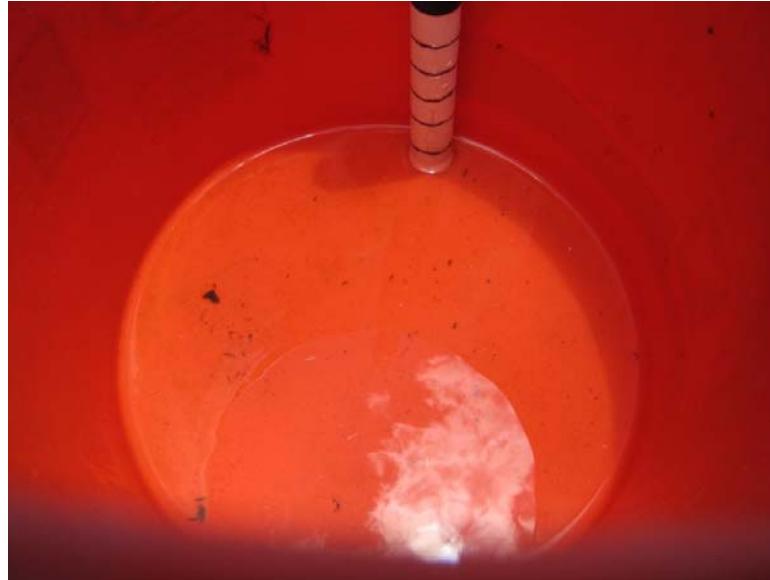
Figure 25. Mannequin B- post-recovery drained water.
